Institute for Environment and Sanitation Studies

UG.IESS.IB.015

The Effects of Volta Floods on Volta Lake Shore Communities

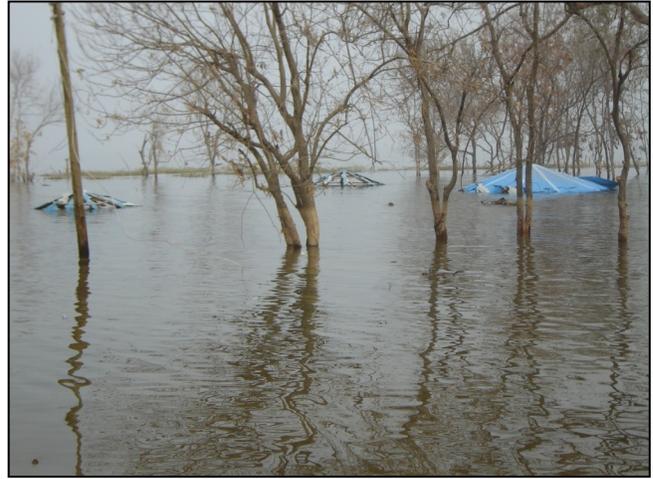
Field investigations revealed that the floods affected all the districts located within the fringes of the Volta Lake. At Buipe in the Central Gonja district of the Northern Region, flood waters inundated homes, public toilet facilities and high tension electric pylons. On the whole, over 25,000 people, mostly women and children, were displaced in the district, and 3,234 houses, including 50 school buildings either collapsed or were submerged. In addition, more than 23,588 acres of farmlands were flooded while a large number of livestock perished. At Yeji in the Brong Ahafo Region, an on-going Small Towns Water Supply System (STWSS) aimed at increasing access to potable water and improved sanitation in the beneficiary communities was completely destroyed. The project which had just commenced before the inundation was designed to cover the period 2010 to 2016. In addition, a recreational as shown in the picture below was completely inundated.

Inundation of recreational facility at Yeji Port.
